Hyde Park Disabilities Task Force

Sidewalk Survey of 55th Street,
from the Lakefront to Ellis Avenue

Final Report
7/12/2012

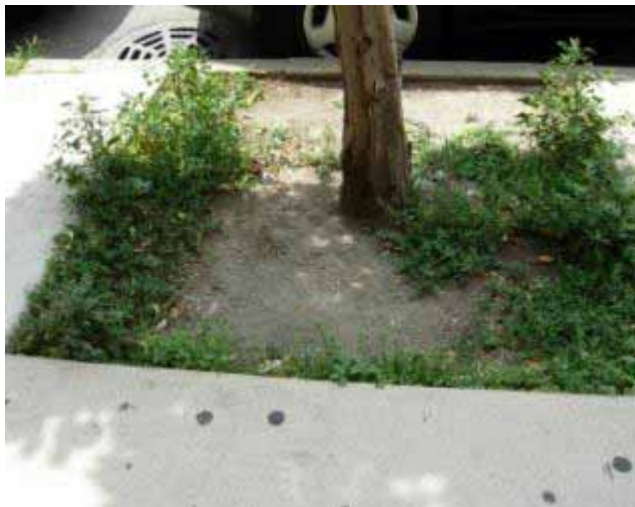
Missing tree grates and uneven surface levels

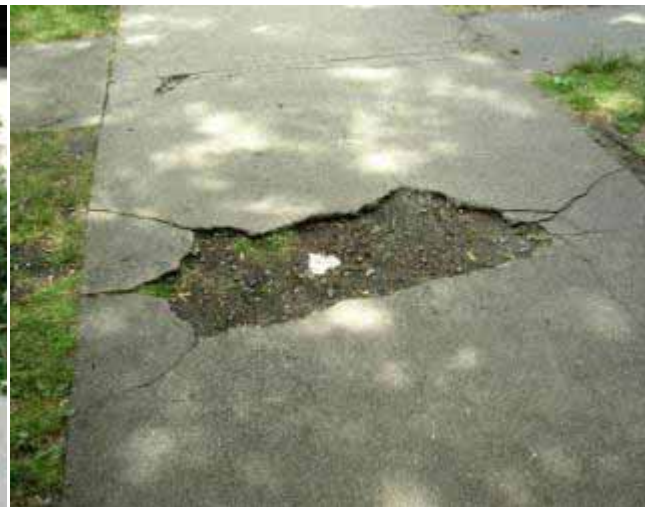
Major sidewalk decay on Cornell

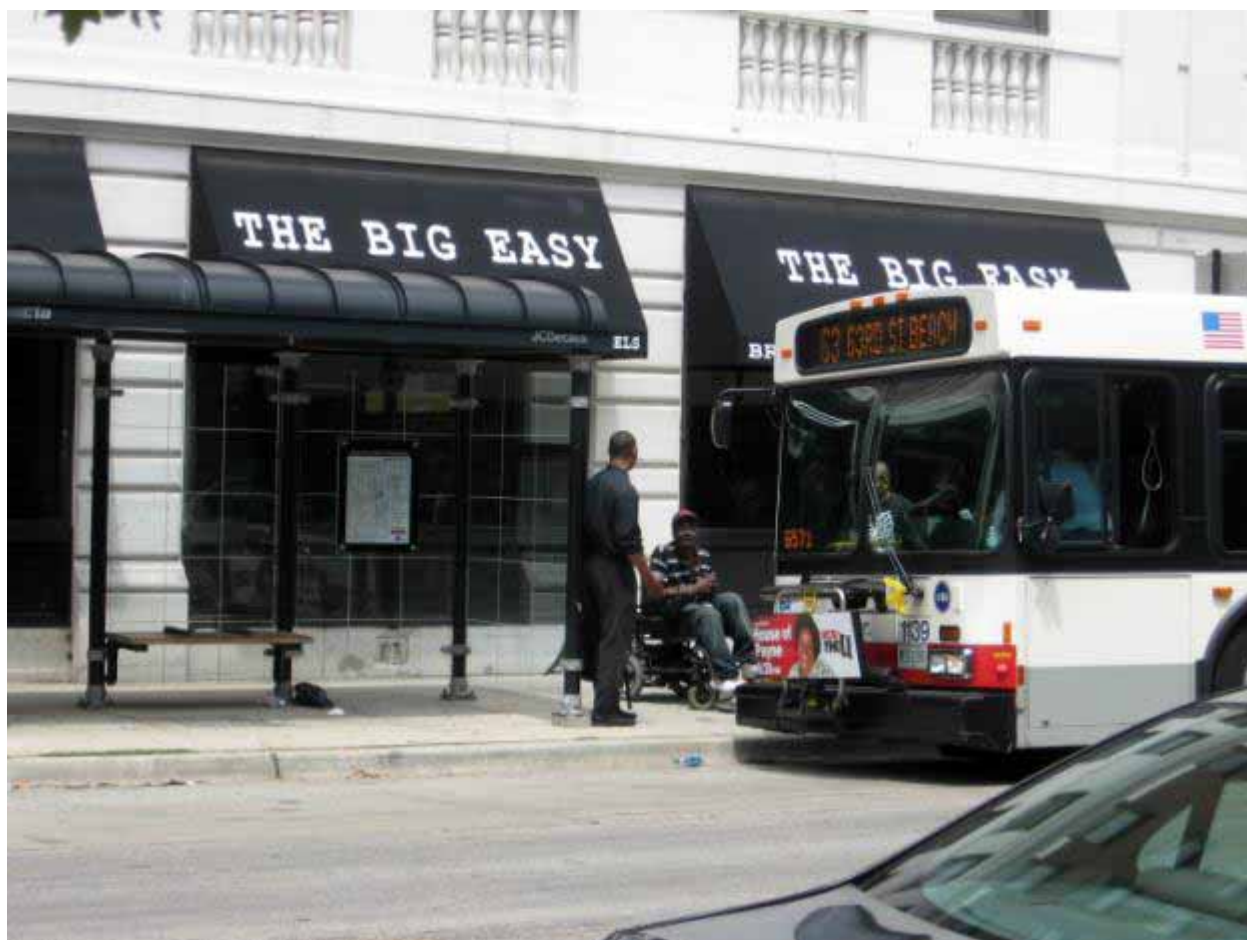
7. Curbs and shelter placement create problems for bus access, particularly by the shelter west of Hyde Park Blvd. on 55th Street. The location of this bus shelter has created problems for the DARE participants. It technically leaves 36 inches of access, but when one DARE resident in a wheelchair tried to lead a second DARE resident with white cane through this part of the survey, it was impossible. (It took two passer-bys to help the gentleman below get on the bus; note the bus cannot be near the shelter.)

Awkward position of bus shelter at 55th and Lake Park, creates difficulties for persons in wheelchairs to board buses

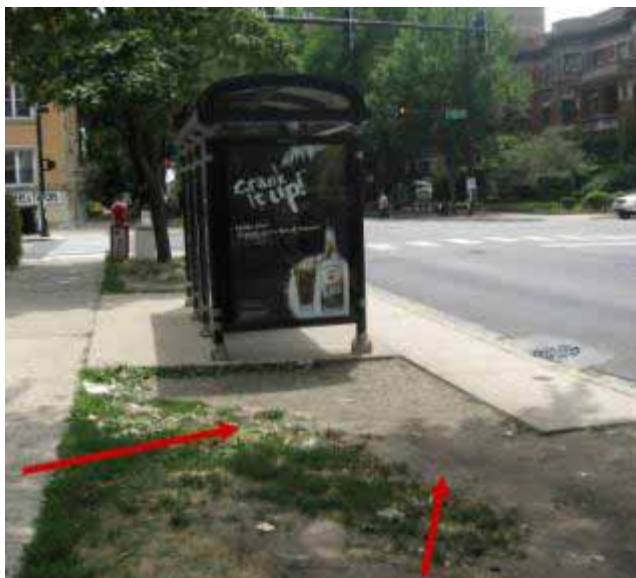
- *Bus shelter on Hyde Park Blvd at 55th (going north).* The shelter is positioned so that wheelchairs must go into the dirt when boarding a bus. The concrete pad could be easily extended.

Concrete pad does not extend far enough for wheelchairs to board bus

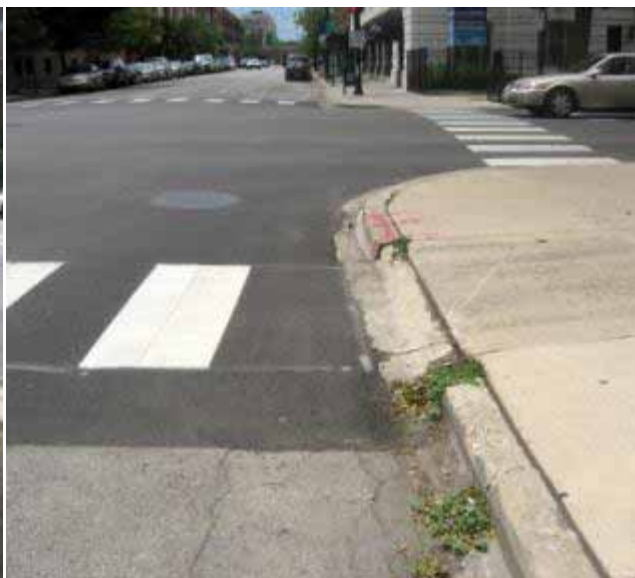
Stepped curb at bus stop, 55th and Hyde Park Blvd, no curb mats or truncated domes

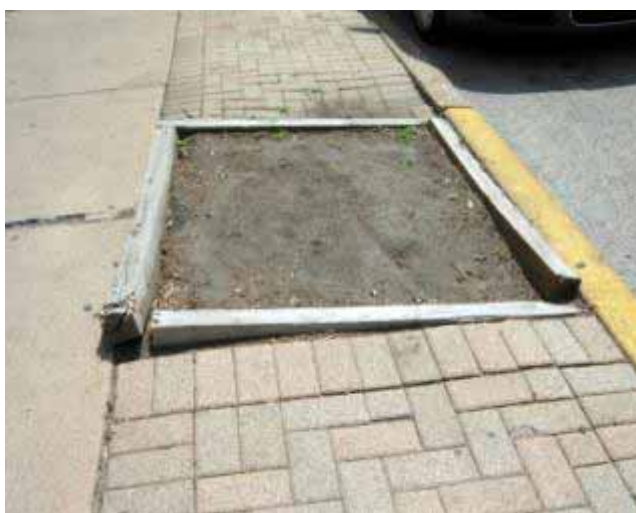
Dangerous landscaping along parkways

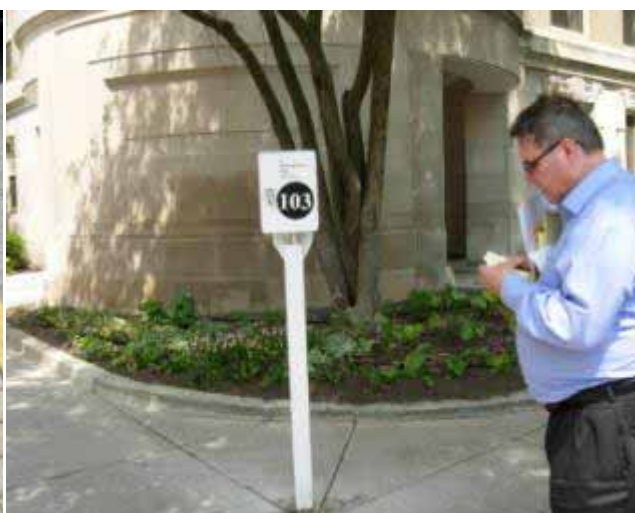
Inappropriate position of safety phone

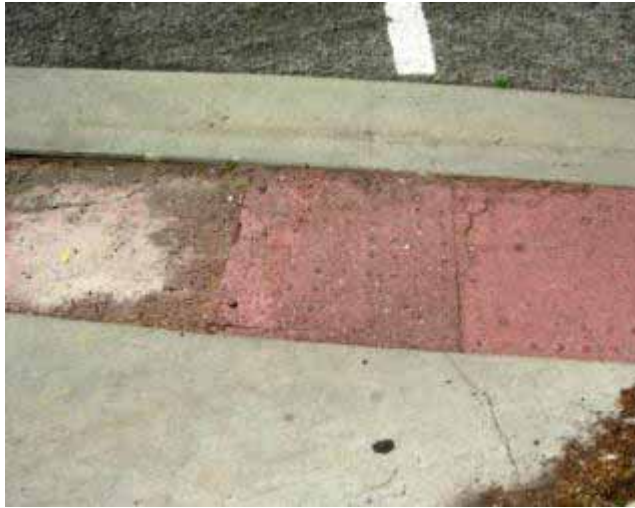
55th and South Shore, deteriorated mats

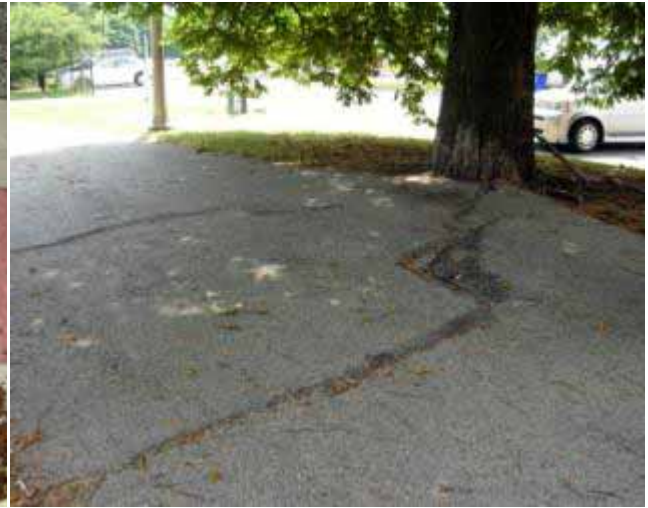
Tree roots create severe crack at entrance to park

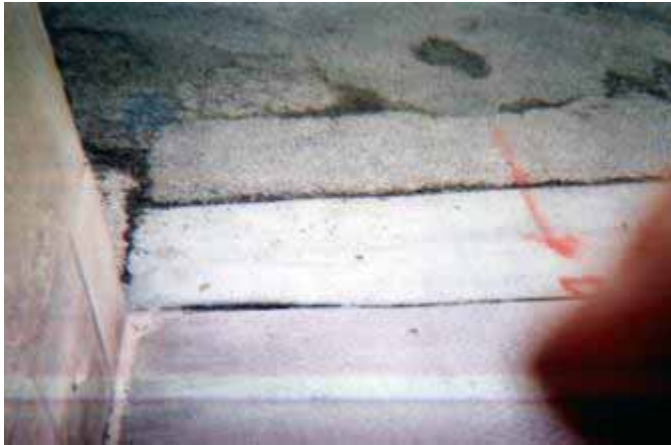
1. At the west edge of the viaduct (by Kikuya's restaurant), the sidewalk at the alley has no warning mats, and where the alley crosses the sidewalk onto 55th Street, it is cracked and filled with holes.
2. The sidewalk between Cornell and Hyde Park Blvd. is badly uneven, with big cracks around manhole covers and missing segments of concrete.

Sidewalk at the viaduct, crossed by alley

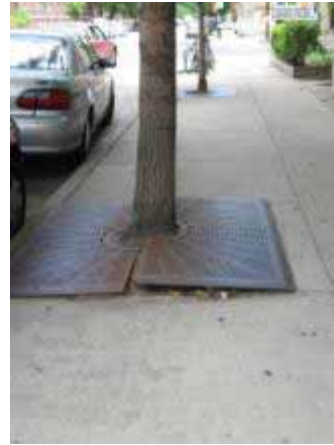
Tree wells at 55th and Cornell

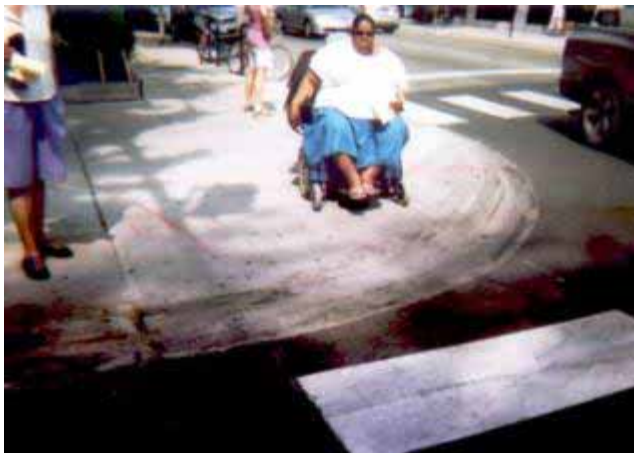
3. Tree wells in this same block are poorly fitted, missing, or protruding hazardously, creating a tripping hazard.
4. The curbs along the intersection at 55th and Hyde Park Blvd. are poorly finished, uneven at the pavement, and lack bump mats.
5. The curb before and after the alley running south by the Park Shore is badly angled and deteriorated.

Intersection, 55th and Hyde Park Blvd

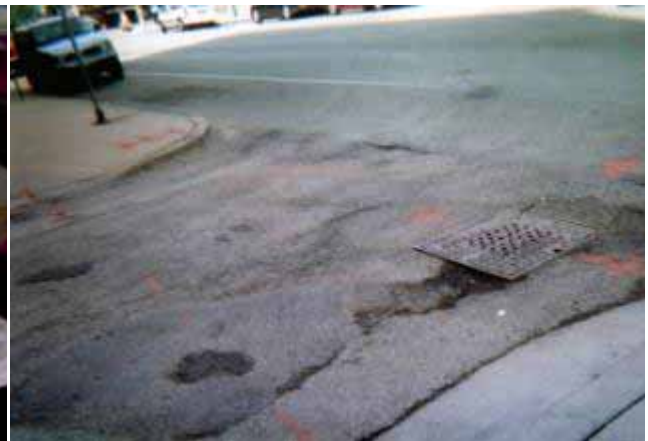
Alley crossing sidewalk near South Shore Drive

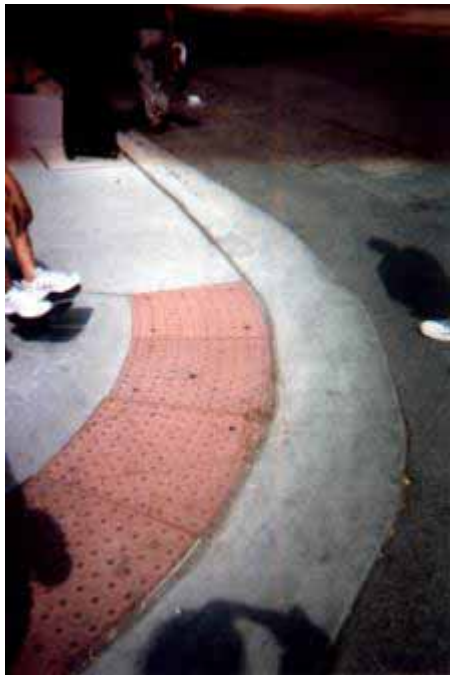
Intersection, 55th and Lake Park

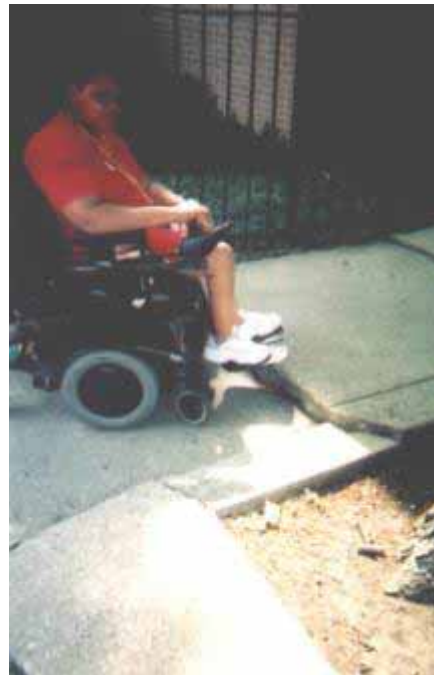
Alley crossing sidewalk near Harper/Blackstone

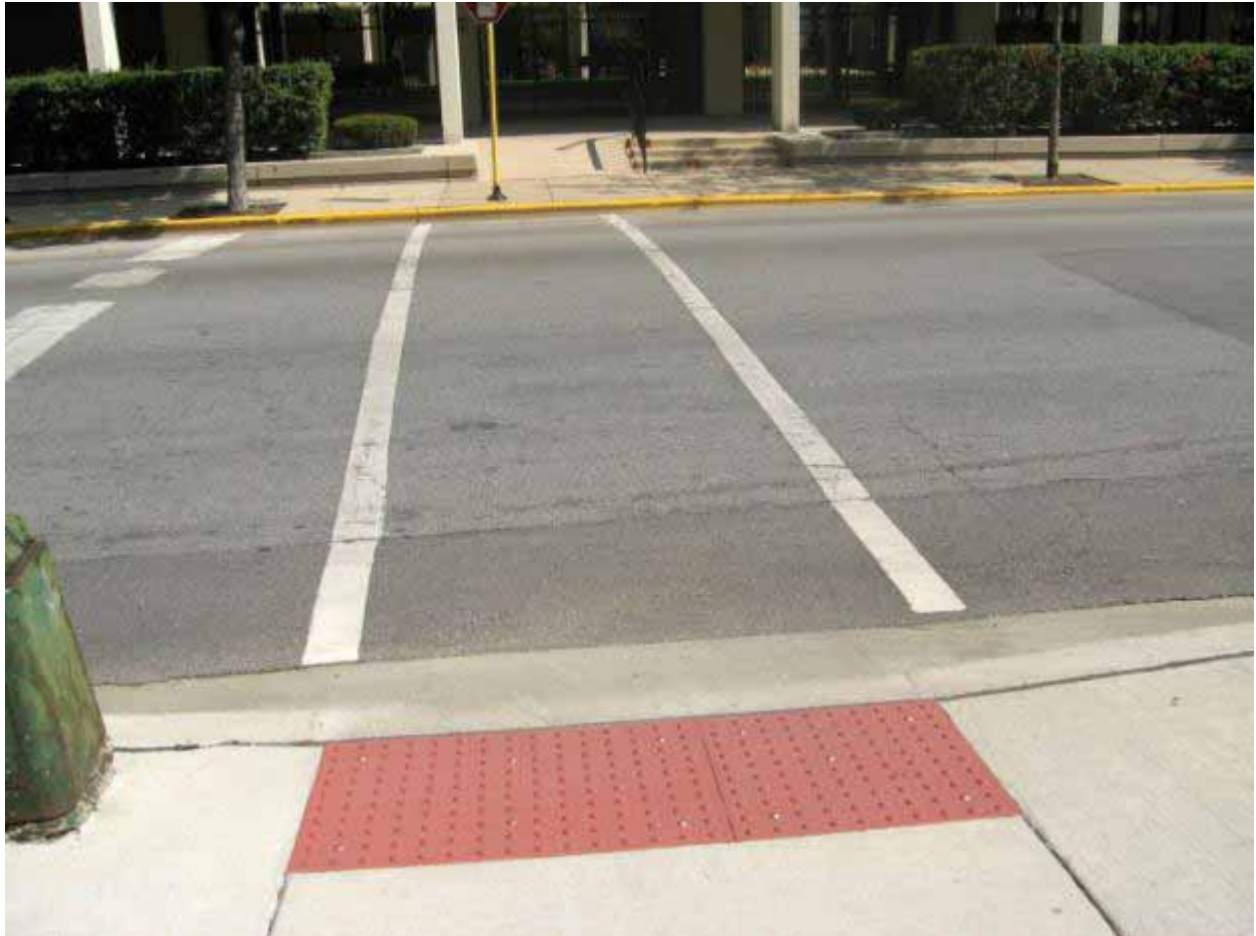
4. University Park (the large condo association in the center of 55th Street) has *no curb cuts* on the south side of the building (north side of street). This is a serious problem because there are curb cuts on the south side of the street, which someone unfamiliar with the area might take as a shortcut, only to find he or she cannot access the sidewalk on the north side of the street.

No curb cuts alongside University Park's south border, between Harper and Kenwood

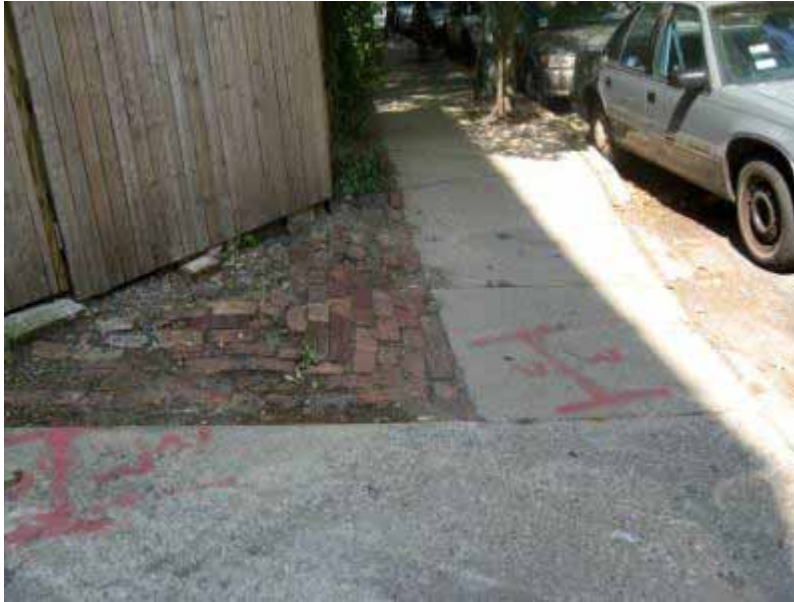
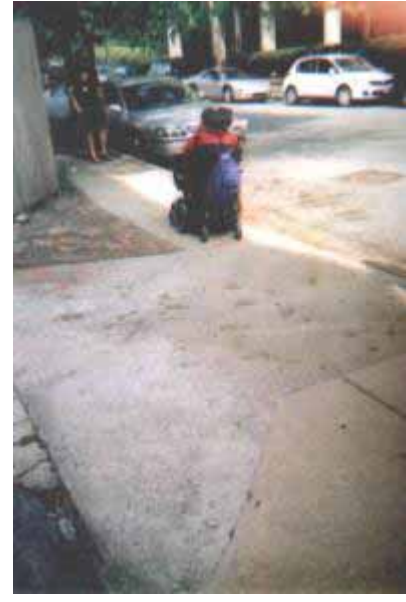
- *The closed-off alley/driveway intersecting the sidewalk at 55th near Dorchester (south side of street).* This closed-off area is a nightmare of bad angles, brick pavers, and narrow access, which forced one wheelchair user into the street.

5. On 55th between Blackstone and Dorchester there is an old unusable driveway. It not on the same level as the rest of the sidewalk. Between that driveway and the corner (which has no mat) the sidewalk is slanted towards the street and very narrow. This is the most dangerous place on the whole street, in the opinion of the team's DARE participant, and the entire block should be re-examined in light of improving safety. In the East 1400s, Team 3's DARE participant was not able to pass, and had to backtrack and go into the street.

Closed-off driveway with bad slope, poor passage; rest of block is narrow with badly cracked sidewalk

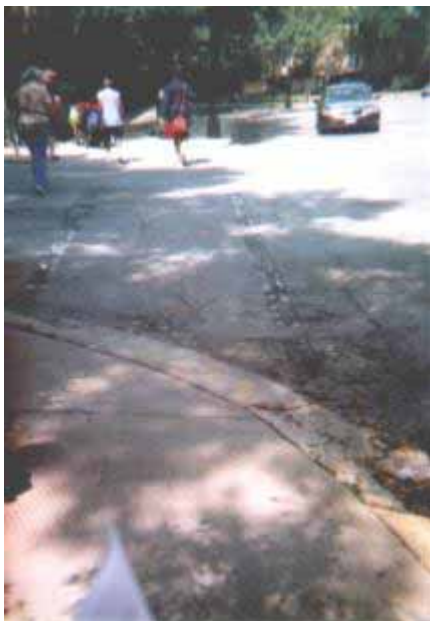
6. There are no detectable warning mats at Dorchester and at Blackstone. The curb slopes in a haphazard way, and because there will be new traffic patterns with the bicycle and bus lanes, these corners become even more of a hazard.
7. There are badly worn warning mats at Woodlawn and at University. Mats are cracked, protruding, or the domes/bumps are so worn as to be useless.

55th and Dorchester, no warning mats, decayed curbs

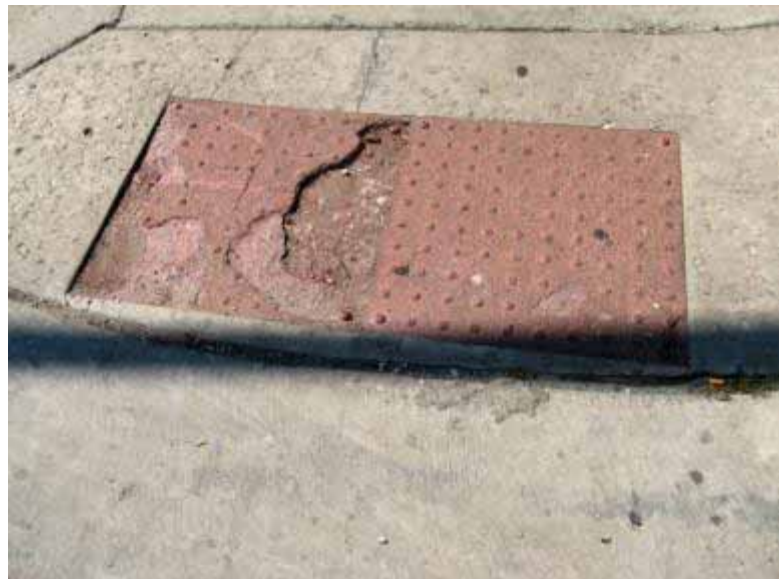
Woodlawn, badly deteriorated warning mats, all 4 corners

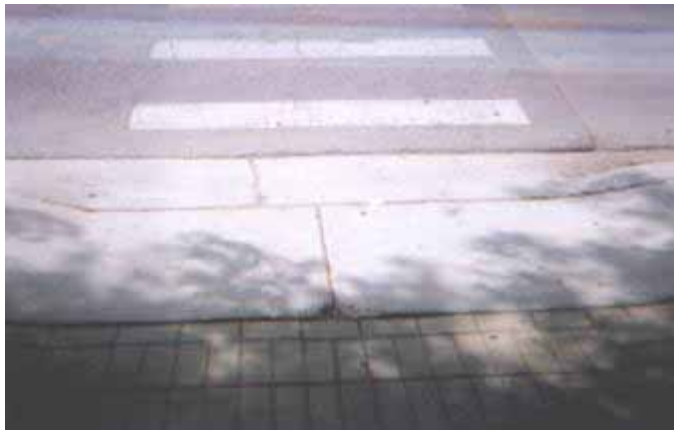
Harper crossing for Hyde Park Shopping Center, no warning mats or bumps

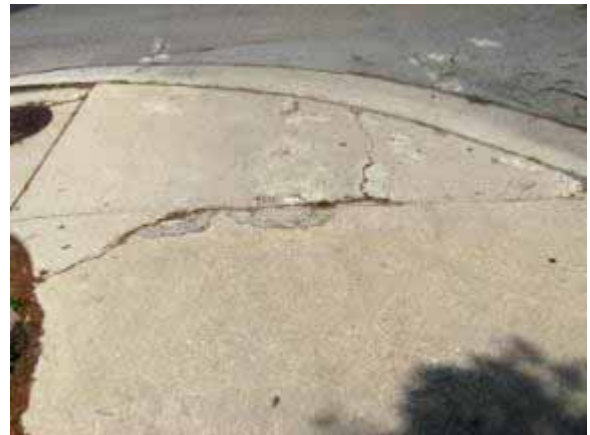
Uneven, ragged, curb at Dorchester, no domes or warning mats

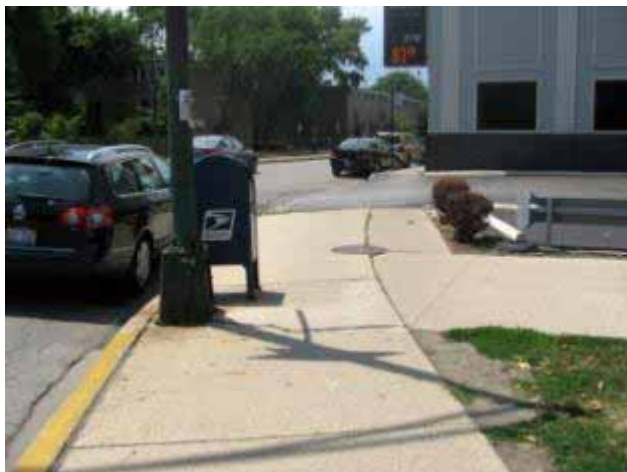
Entrance to BankFinancial drive-thru, with poor slopes and crumbling pavement

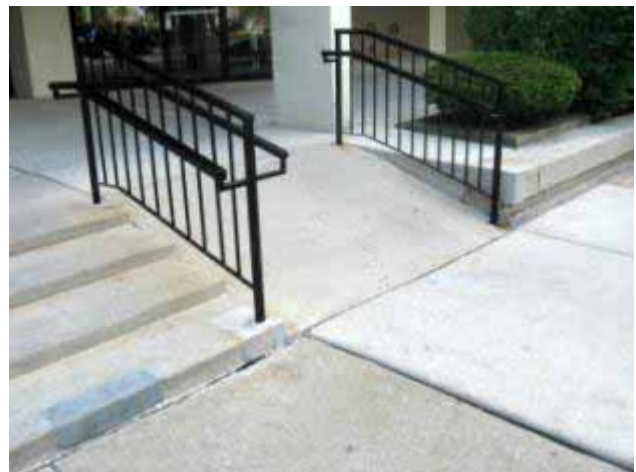
Entrance to University Park, with ramp above curb that is extremely steep

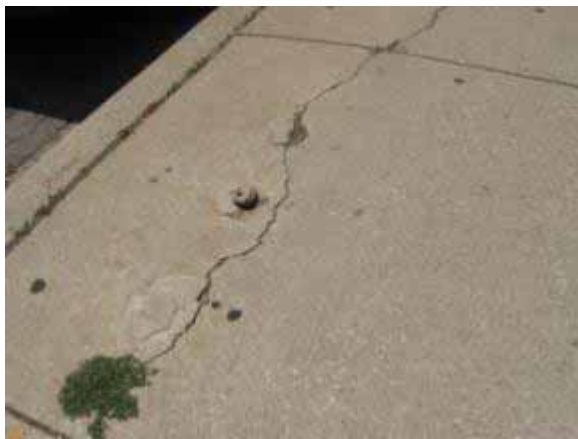
Water, gas caps, parking meter stubs exposed or open, Woodlawn

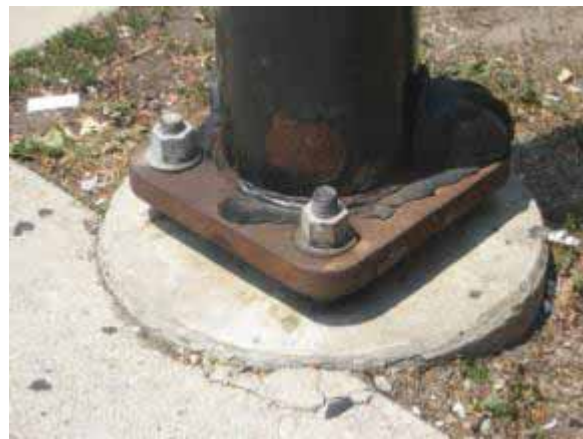
Several light poles with exposed bases between Kenwood and Woodlawn

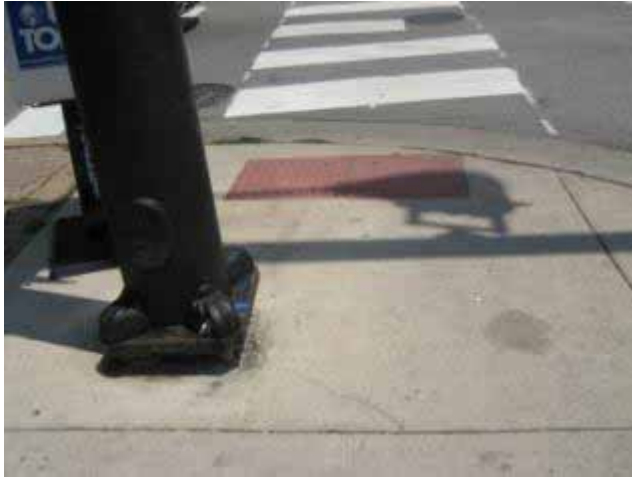
Obstructed and awkward ramp at Starbucks

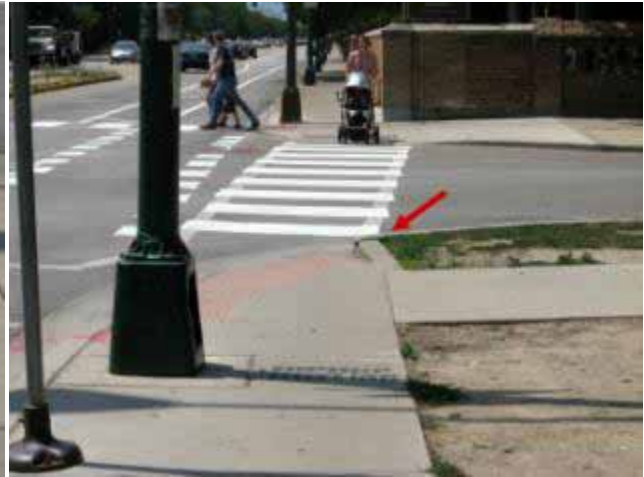
Curbs and mats that don't align with cross walk, Kimbark and again at University

12. The placement of the curb mats at 55th and Kimbark do not properly align with the crosswalk. Someone following the curb onto the street will end up in traffic.
13. The curb cuts and ramp mats at 55th and Woodlawn are in very poor condition: cracked, worn, and loose. The problem is made worse by newspaper vendor boxes that are positioned right on the corner (in front of Starbucks), on top of the curb ramps.
14. The sidewalk along Starbucks (leading to the Starbucks' accessibility ramp) is paved with brick, which has become badly uneven due to tree roots.
15. An unused pipe extends from the kidney dialysis center wall out to the sidewalk.

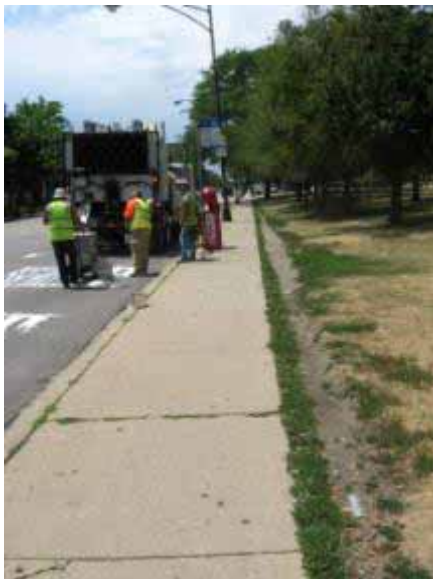
Narrow sidewalk from Dorchester to Kimbark, particularly along Nichols Park

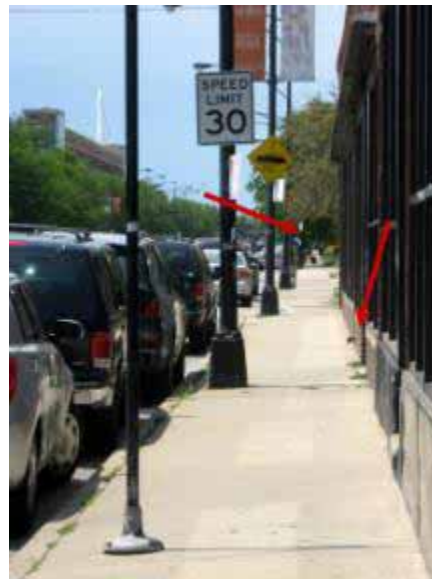
Pipes that extend into the sidewalk, low-hanging trees, Woodlawn to Ellis

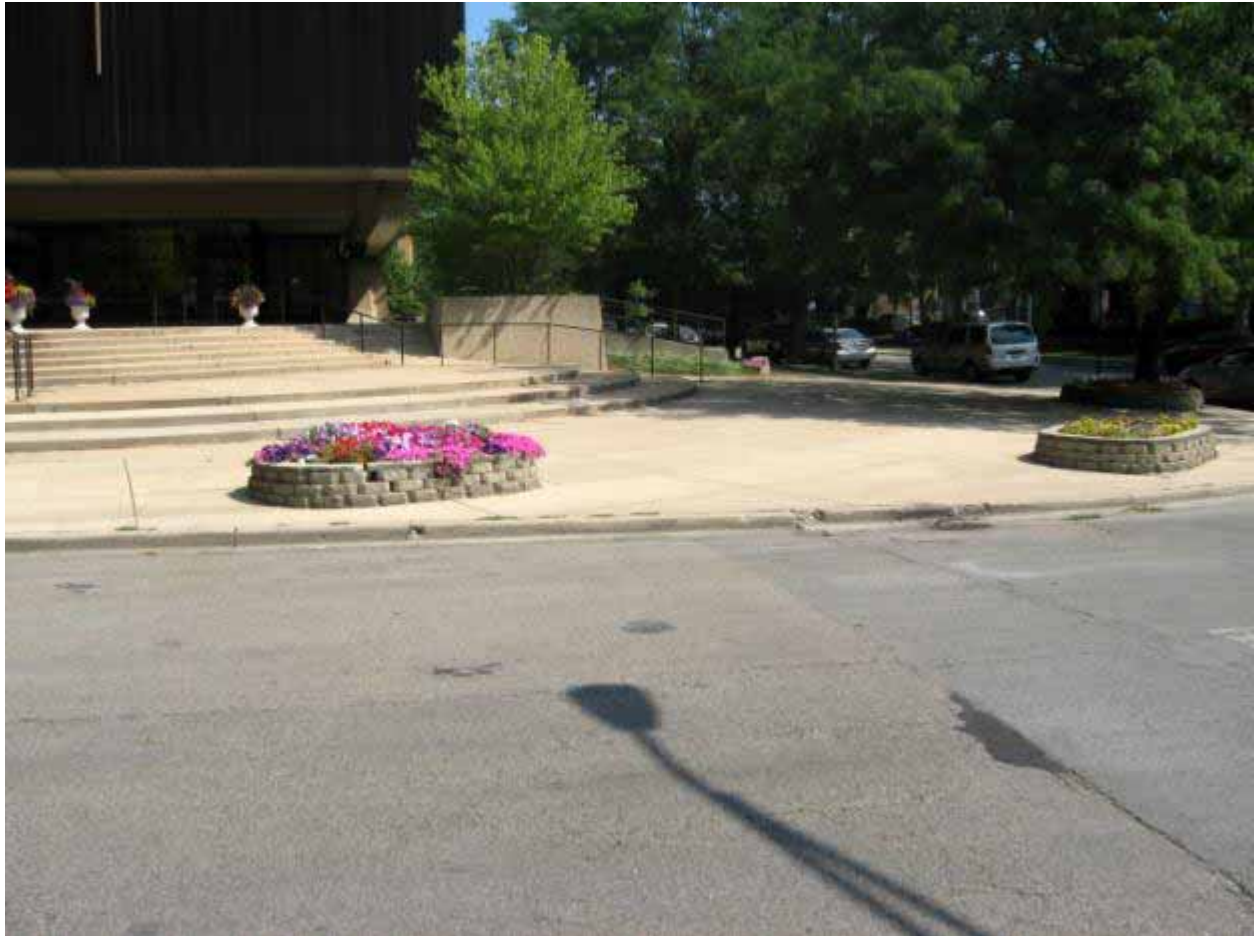
No curbs cuts along the entire south side (entrance) of Lutheran School of Theology
