Hyde Park Disabilities Task Force

Sidewalk Survey of 55th Street,
from the Lakefront to Ellis Avenue

Final Report
7/12/2012

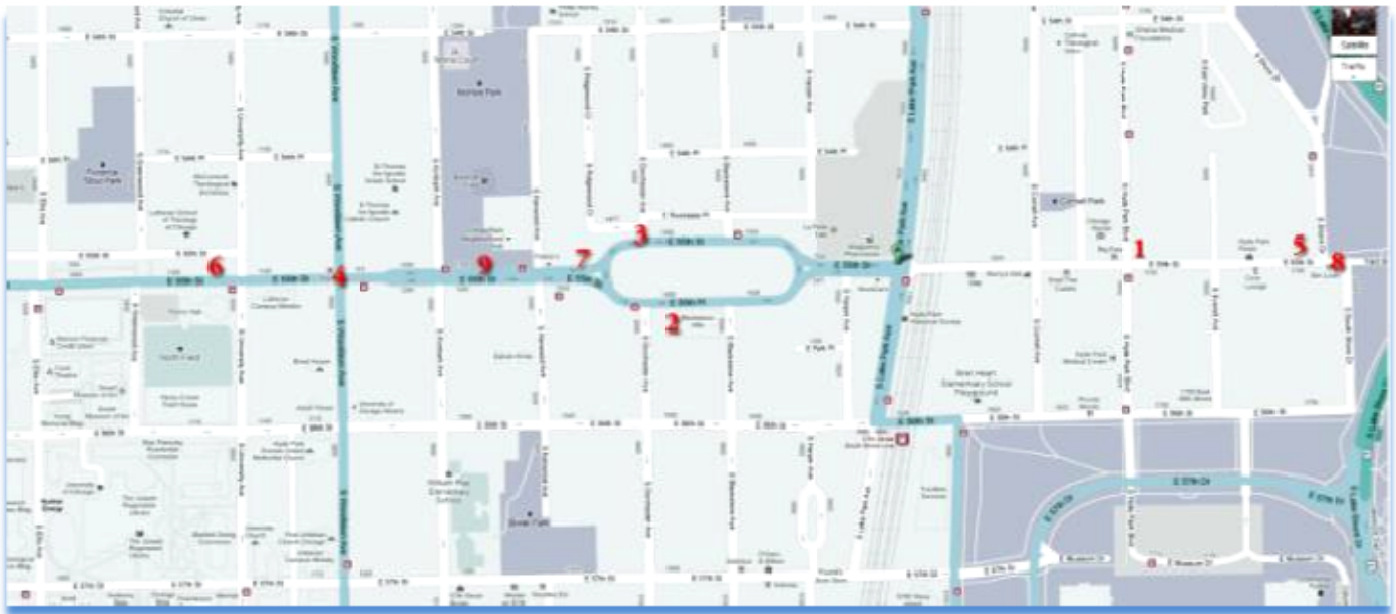
9 Critical Areas That Will Make a Difference

1. Bus shelter on Hyde Park Blvd at 55th (going north)
2. Alley/driveway crossing on 55th near Dorchester (south side of street)
3. Intersection 55th and Dorchester (north side of street)
4. Low-hanging branches on 55th and curbs at Lutheran School (north side of street)
5. Parkways at 5490 (north side of street)
6. Intersection of 55th and Woodlawn (all 4 corners)
7. Entrance to BankFinancial drivethru (north side of street)
8. Intersection of 55th and South Shore Drive (all four corners)
9. Sidewalk and bus stops along Nichols Park
